Smoke and Dye-Water Observation Summary

Western Run Pilot Project - Baltimore Maryland

FIELD SKETCH

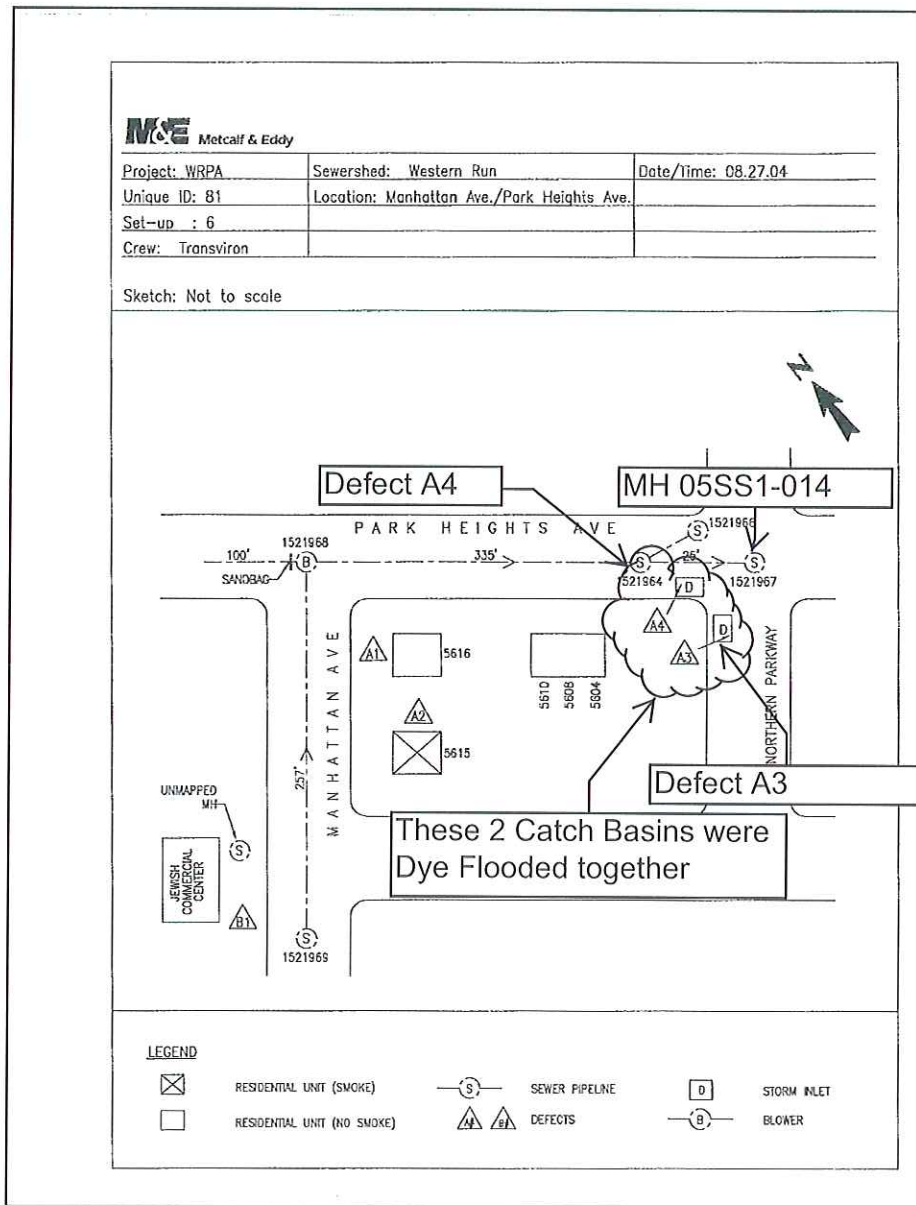
Sketch No: 81

Sketch (NTS)
Dye Test 81

Dye Flooded this
Catch Basin

Defect A3

THIS C.B. (A3)

Defect A4

MH 05SS1-014
